**EP 0 808 913 A1**

**EUROPEAN PATENT APPLICATION**

**(54) Method for repairing a thermal barrier coating**

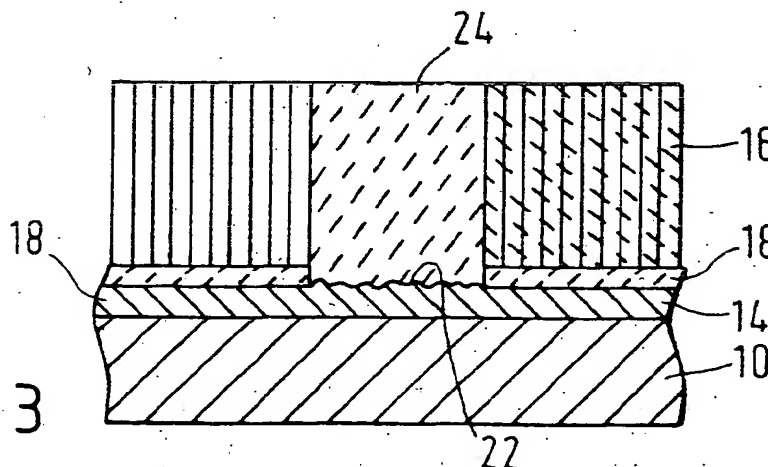
**FIG. 3**

Due to process control limitations, the ceramic material will typically be deposited until the surface of the repair layer 24 projects above the surrounding surface of the ceramic layer 16, as shown in Figure 2. Afterwards, the surface of the repair layer 24 is polished or otherwise abraded until the repair layer 24 is substantially level with the ceramic layer 16, and the repair layer 24 merges with the ceramic layer 16 as portrayed in Figure 3.

Figures 2 and 3 are cross-sectional representations of repair steps entailed in a preferred embodiment of this invention.

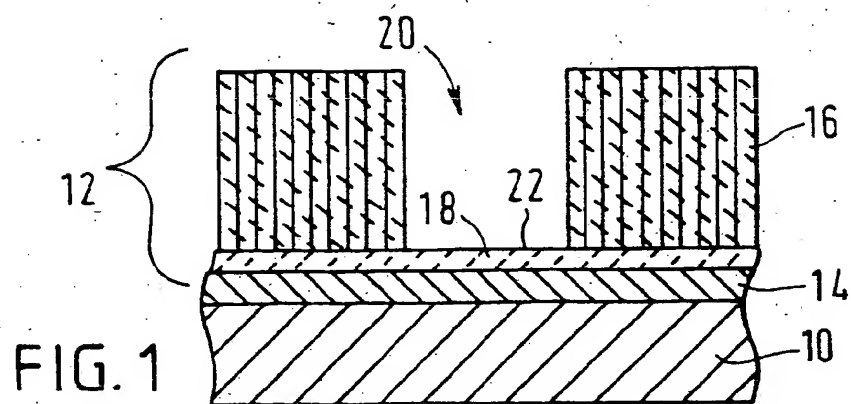
Figure 1 shows a cross-sectional representation of a component that has suffered localized spallation;

As represented in Figure 1, the method of this invention is particularly suited for the repair of a thermal barrier coating system 12 composed of a metallic bond layer 14 formed on the surface of the article 10; and a columnar ceramic layer 16 overlaying the bond layer 14. As is the situation with high temperature components of a gas turbine engine, the article 10 may be formed of a nickel-base or cobalt-base superalloy. The bond layer 14 is preferably formed of a metallic oxidation-resistant material, so as to protect the underlying article 10 from oxidation and enable the ceramic layer 16 to more tenaciously adhere to the article 10. A preferred bond layer 14 is formed by a nickel-base alloy powder, such as NiCrAlY, or an intermetallic nickel or platinum aluminide, which has been deposited on the surface of the article 10 to a thickness of about 20 to about 125 micrometers. Preferred methods for depositing bond layers of the type described above include vapor deposition techniques for aluminide coatings and low pressure plasma spray (LPPS) techniques for a NiCrAlY bond coat, though it is foreseeable that other deposition methods such as air plasma spray (APS) or physical vapor deposition (PVD) techniques could be used. Following deposition of the bond layer 14, an oxide layer 18 such as alumina may be formed on the surface of the bond layer 14 at an elevated temperature. The oxide layer 18 provides a surface to which the columnar ceramic layer 16 can tenaciously adhere, thereby promoting the resistance of the coating system 12 to thermal shock.

As a component of a gas turbine engine, surfaces of the article 10 are subjected to hot combustion gases during operation of the engine, and are therefore subjected to severe attack by oxidation, corrosion and erosion. Accordingly, the article 10 must remain protected from the hostile environment of the turbine section by the thermal barrier coating system 12, and loss of the ceramic layer 16 will lead to premature and often rapid deterioration of the article 10. Localized spalling 20 of the ceramic layer 16 is represented in Figure 1, with the repair process of this invention being represented in Figures 2 and 3.

The repair method of this invention begins with cleaning the bond layer 14 exposed by the localized spalling 20 so as to remove oxides and any residual fragments of the ceramic and oxide layers 16 and 18. While various techniques can be used, a preferred method is to grit blast the exposed surface of the bond layer 14, such as by a technique known as pencil grit blasting. This step is selectively performed to ensure that the remaining ceramic layer 16 is not subjected to the procedure. It may be desirable to mask the surrounding ceramic layer 16 with, for example, tape masking, during the grit blasting operation. In addition to providing a level of protection to the ceramic layer 16, tape masking would also serve as a proof test for the integrity of the ceramic layer 16 immediately surrounding the spalling 20.

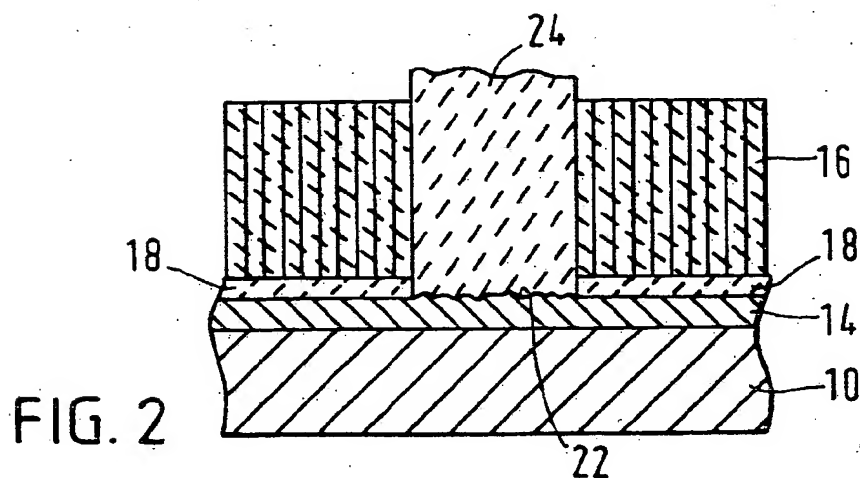
Once free of contaminants, the bond layer 14 is then treated such that its surface 22 becomes textured, as represented by Figure 2. Preferred treating methods include grit blasting, micromachining, photolithography, laser etching and water jet techniques. Preferred grit blasting media include alumina, though other materials could be used. Suitable micromachining techniques include the use of mechanical indentors or cutting tools, the latter being dragged over the surface of the bond layer 14 to form an array of grooves. Finally, suitable photolithographic techniques include the use of positive or negative photoresists to form masks through which a suitable etchant is applied to chemically etch the surface of the bond layer 14. A preferred technique is to use a positive photoresist and an etching solution composed of, by weight, about twenty parts of hydrofluoric acid, about fifteen parts of sulfuric acid, about five parts of nitric acid, and about sixty parts of water.

Finally, as represented in Figure 2, a ceramic material is then deposited on the textured surface 22 of the bond layer 14 so as to form a ceramic repair layer 24 that completely covers the bond layer 14. A preferred deposition method is a plasma spray technique process, though physical vapor deposition techniques can be used to deposit the ceramic material such that the repair layer 24 has a columnar grain structure. With either technique, the ceramic layer 16 is masked to prevent deposition of the repair material on the ceramic layer 16. According to this invention, the preferred repair method is to form the repair layer 24 by plasma spray, the random ceramic grain structure of which is represented in Figures 2 and 3. Generally, masking of the surrounding surface of the ceramic layer 16 is less complicated if a plasma spray deposition technique is used. For example, if any holes are intentionally present in the article 10, such as cooling holes often present in airfoils to reduce their operating temperature, fibers can be placed in the holes or a gas can be flowed through the holes in order to prevent closure by the deposited ceramic. Furthermore, physical vapor deposition techniques generally result in the entire article 10 being heated to a high temperature, whereas plasma spray techniques directly heat only the localized region being repaired on the article 10.

The treatment selected should sufficiently texture the surface 22 of the bond layer 14 to yield macro surface features, resulting in an average surface roughness  $R_a$  of at least about 300 micrometers. With laser techniques, such macro surface features can be in the form of a groove pattern that is selectively developed on the surface 22 of the bond layer 14. Laser techniques, and to a lesser extent grit blasting and water jet techniques, are also capable of producing a desirable combination of macro and micro surface features, as dis-
